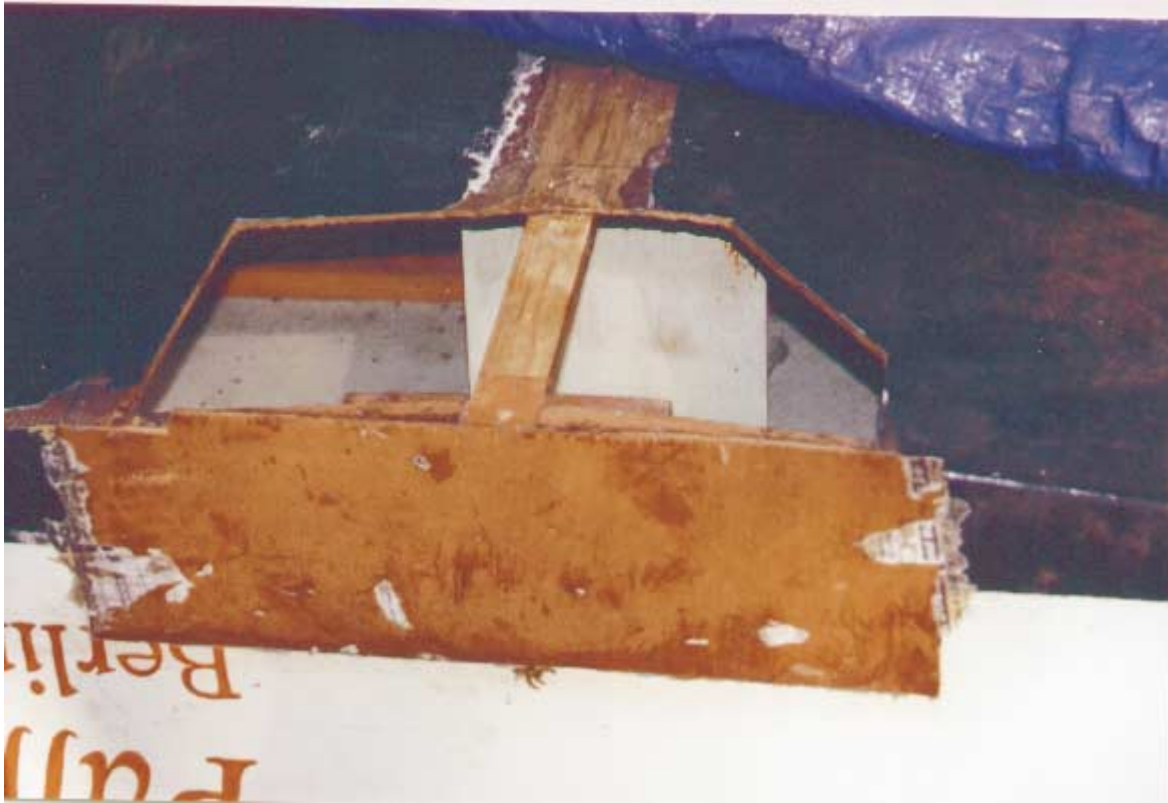
This is what a hole looks like after the rotten bit has been cut away. The patch on the transom was done in a similar fashion. The thick piece of wood against the plywood is not original, but “invented” by me in order to keep the plywood flat when clamped in place waiting for the epoxy glue to set. Same applies to the “keel” bit. I intended to bend a single sheet of ply over the hole shown here.

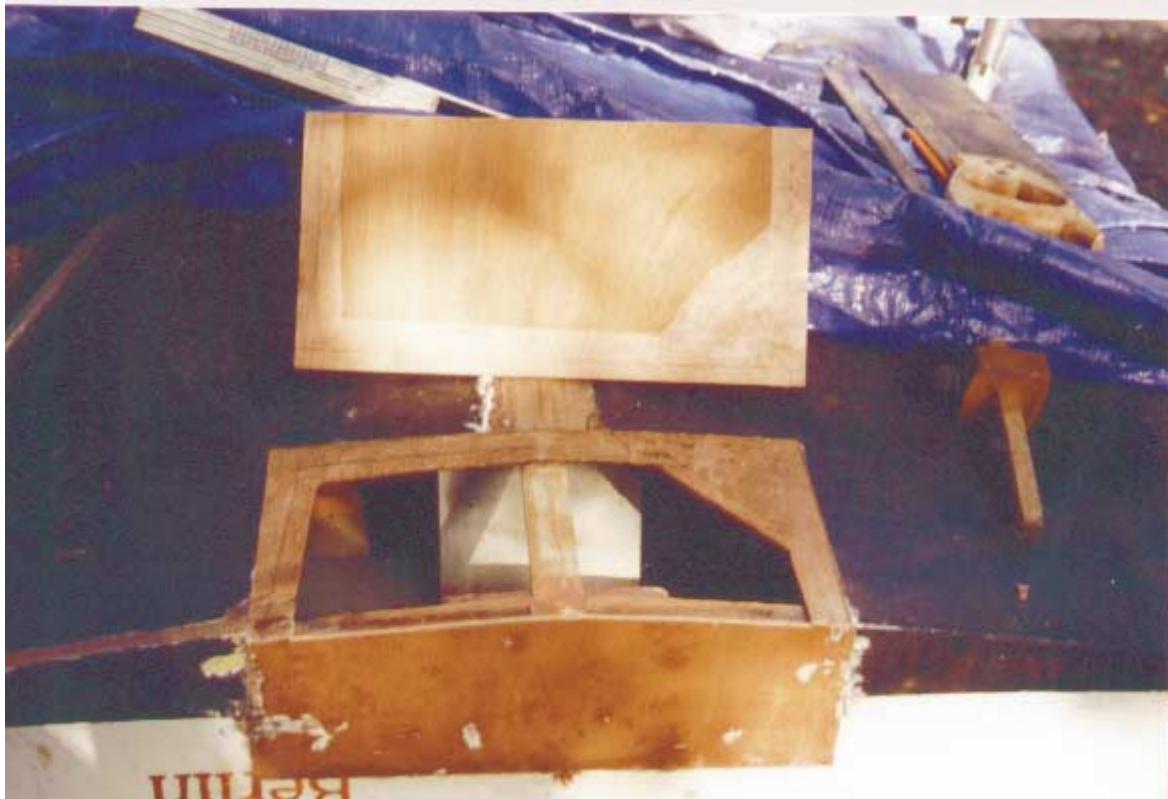
The next picture shows how the plywood was peeled away at the edges in two layers to get a smoother fit. Unfortunately, good marine plywood was not available in the thickness of the original rot-prone stuff and the material I used to fix the holes is thinner than the original, so I did not get a perfectly smooth finish. I glued the patch in place with epoxy resin glue (West system), placing weights assisted by a web strap around the boat, on the patch to bend it into shape and hold it while the glue set. *Gernot Hirsinger - Gernot@technomedia-translations.de*
